# The Grapevine Hill Fault - A New Fault Discovered During Preliminary Geotechnical Exploration For Route Construction

Route US 50, Osage County  
Missouri

# Presented to the 50<sup>th</sup> Annual Meeting of the American Institute of Professional Geologists

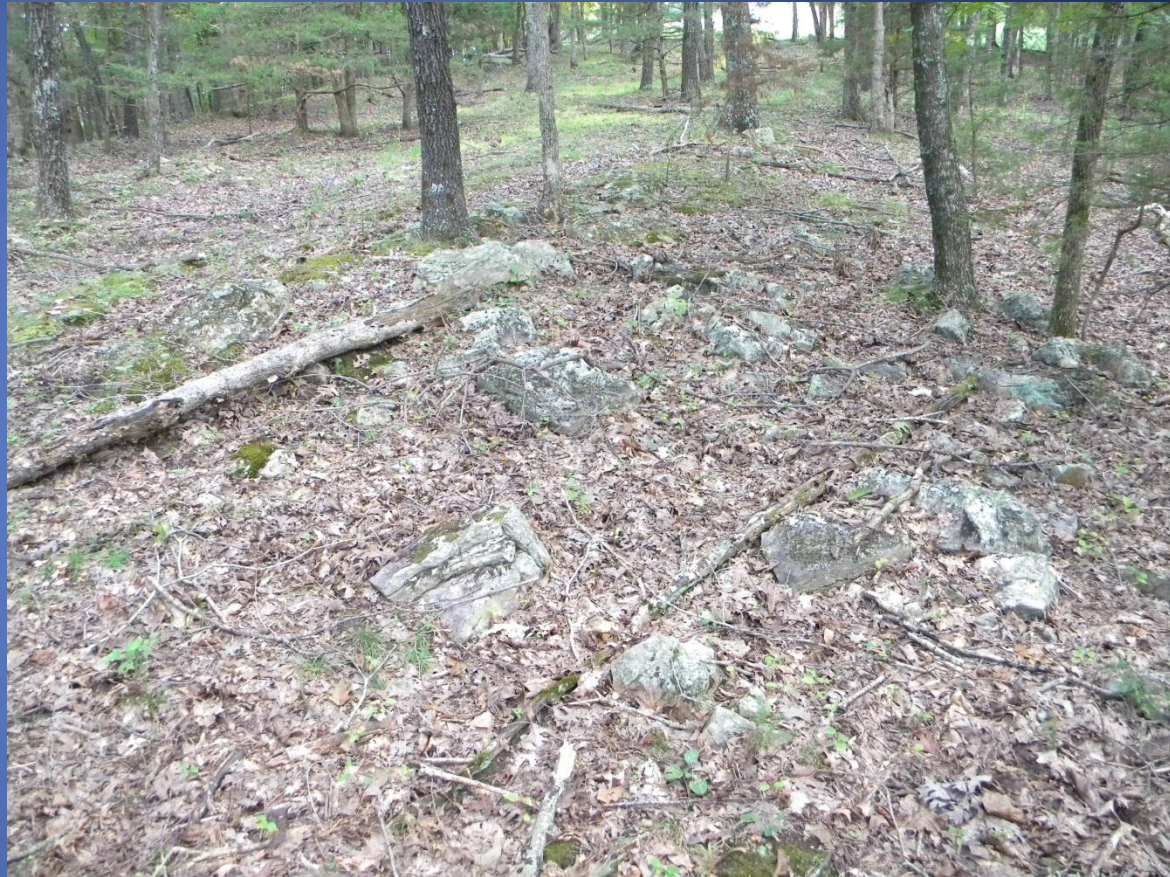
“Filled-sink” structures are known to occur in the survey area. Some are mined for refractory clay. This particular sink occurs on Grapevine Hill, and is unique in that it possesses quaquaversal bedding dipping towards the center.

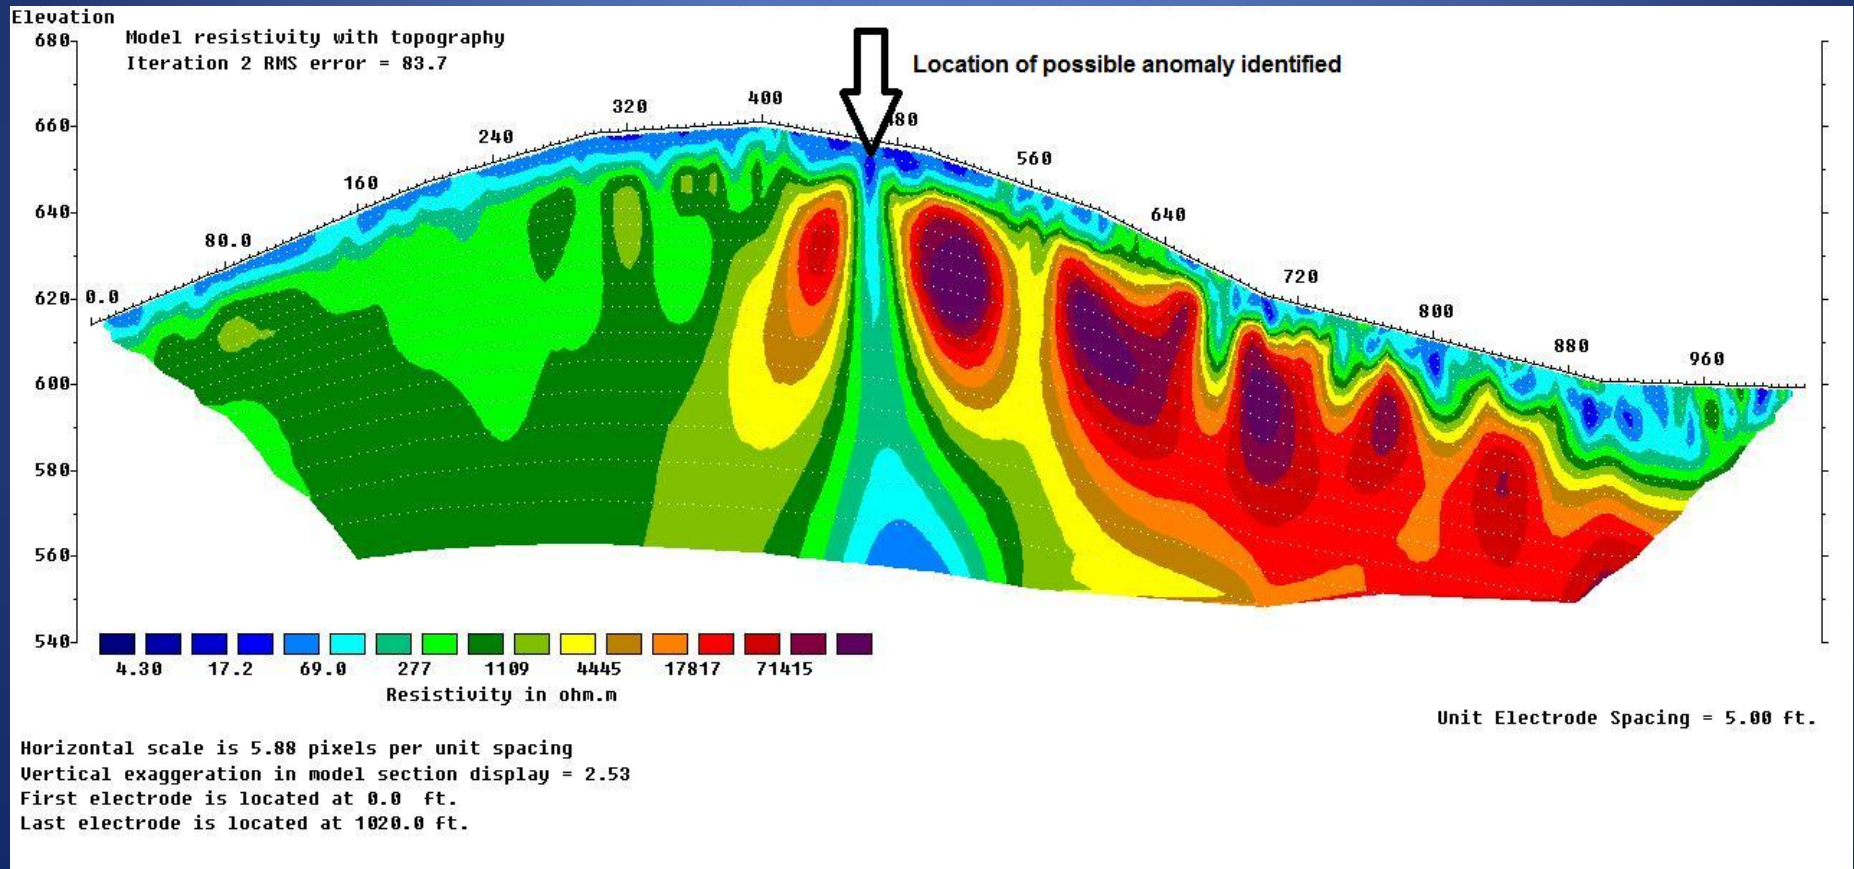
# Grapevine Hill Traverse Locates possible anomaly

1. The anomaly may be interpreted as a  
‘filled-sink’ structure  
-favored since filled-sink already found  
on Grapevine Hill.
2. The anomaly may be interpreted as  
another structural feature.

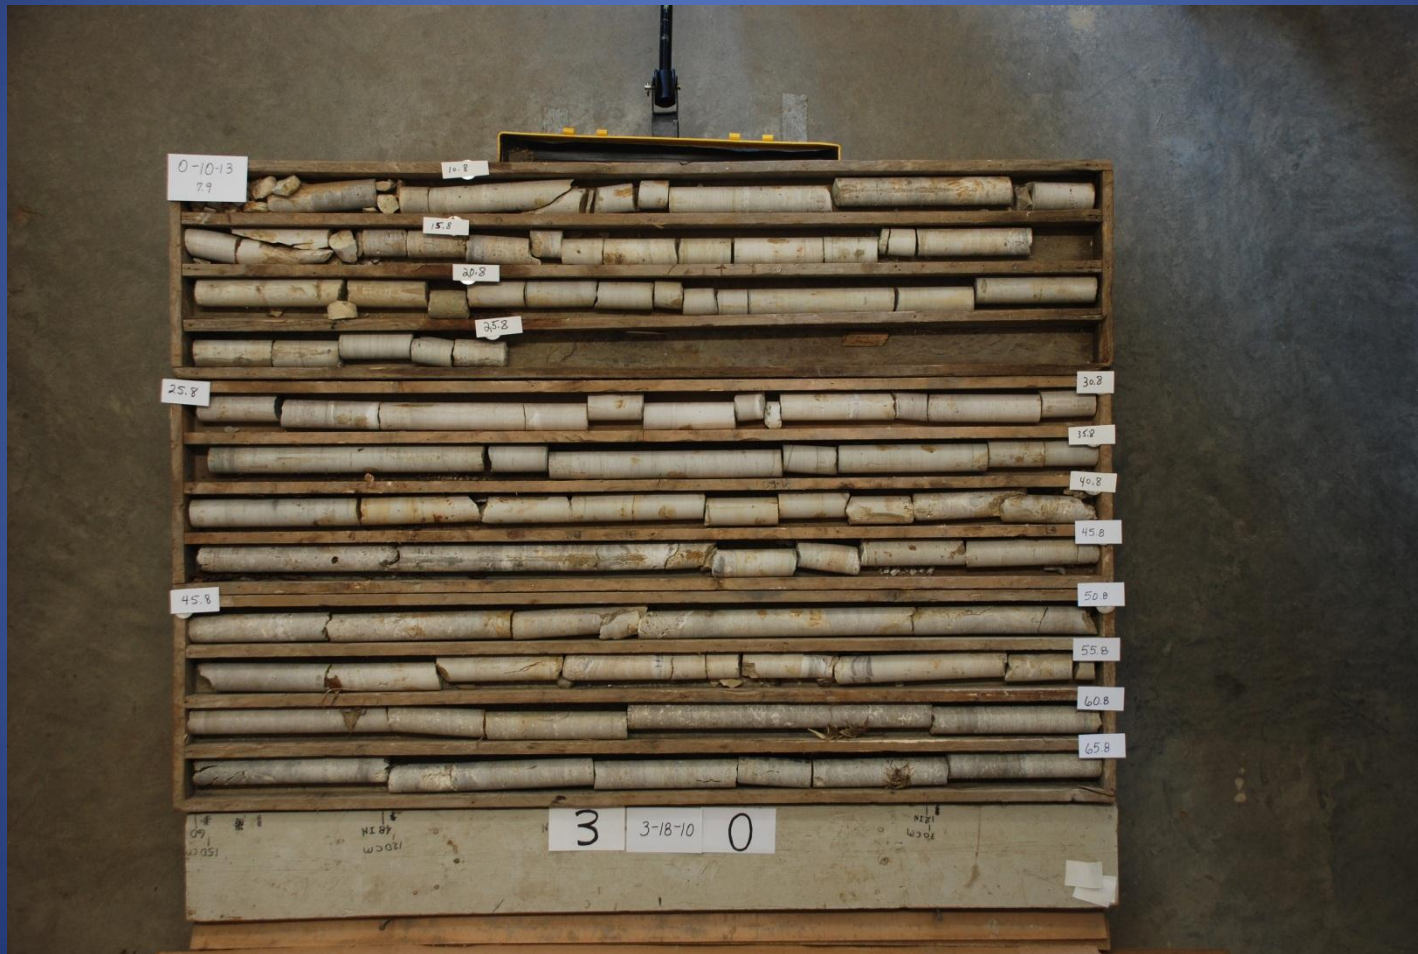
Three holes were continuously cored to  
10' below planned ditch line.

- There was NO filled-sink structure.
  - ALL of the borings did not encounter any type of sandstone or refractory clay.
  - There was none of the brecciation normal associated with a filled-sink deposit.
- Had to be a structural feature.
  - BUT WHAT?
  - Returned to the core to reexamine and plot key beds on a cross-section.

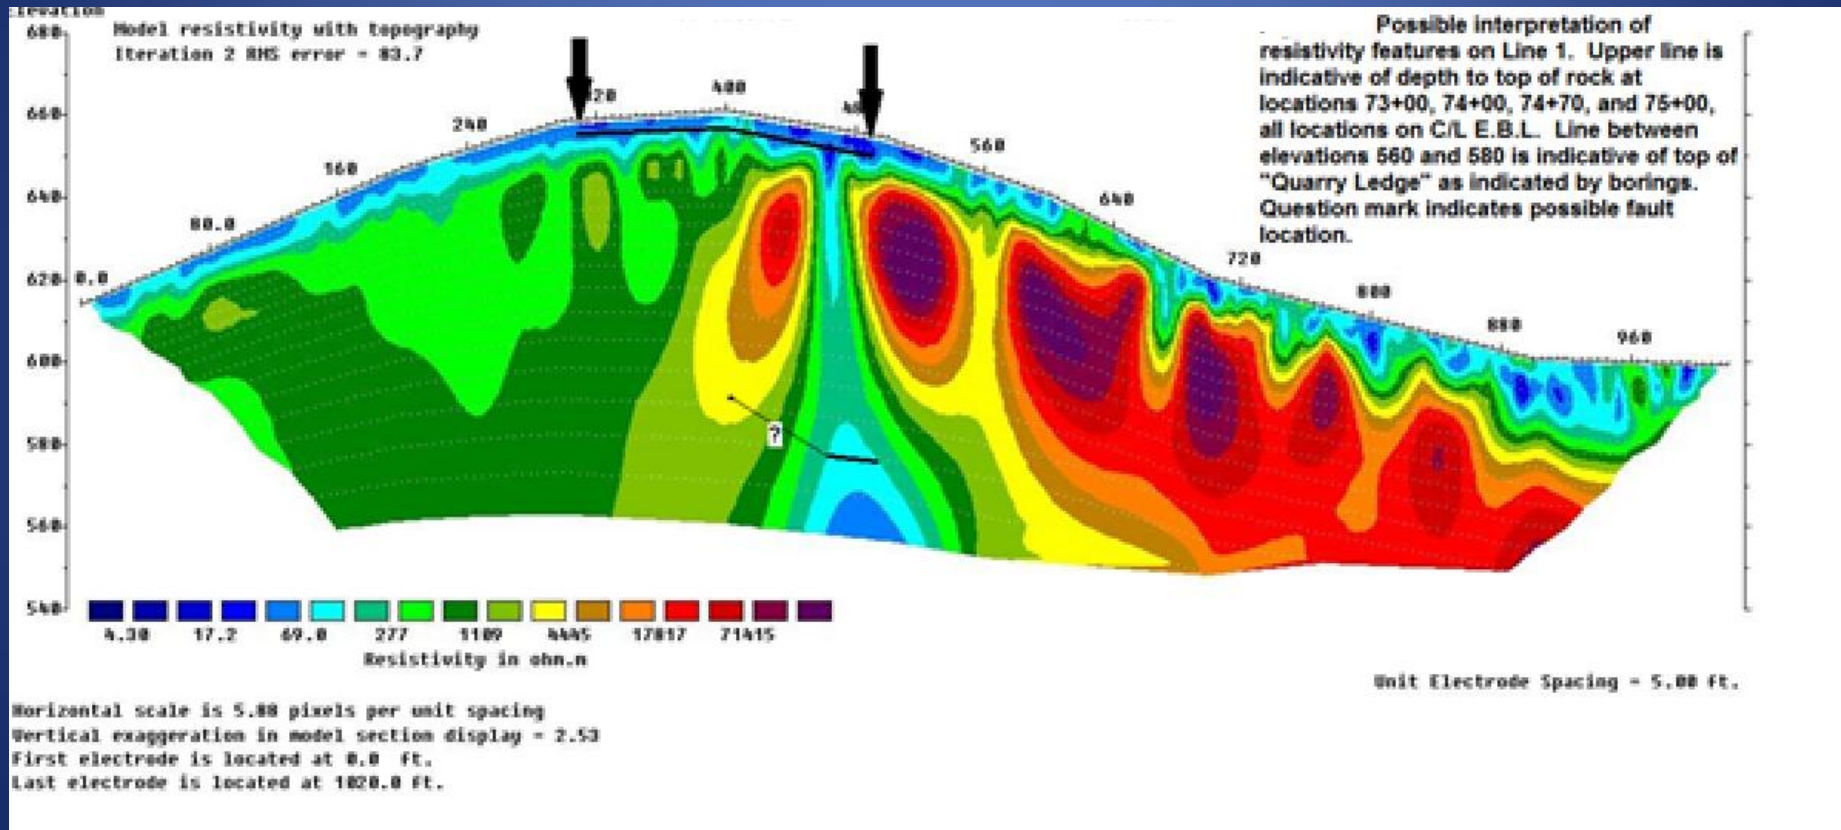
What's this? A 10-FOOT DIFFERENCE?

# Strike and dip of the rock units is nearly level.

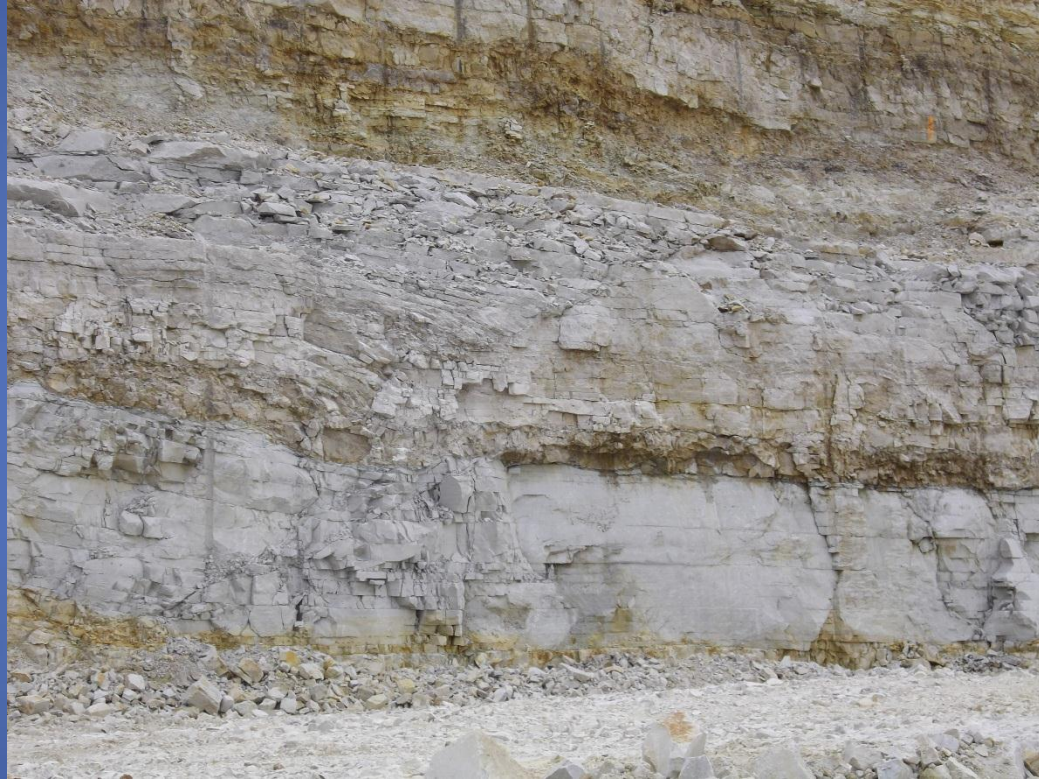
The Grapevine Hill Fault  
Exposed during construction 2013

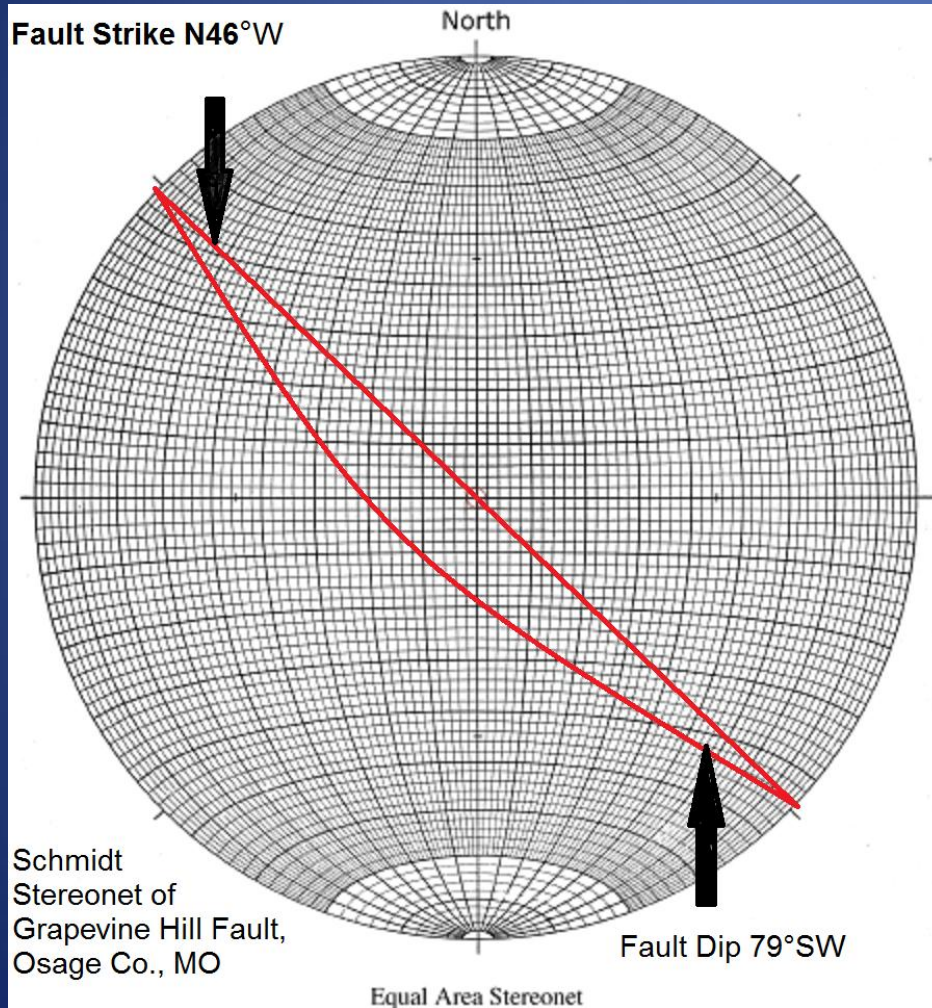
Next step:  
Plot the fault on a stereo net, and compare it to the cut face to determine if the fault represents a problem for the safety of the roadway.

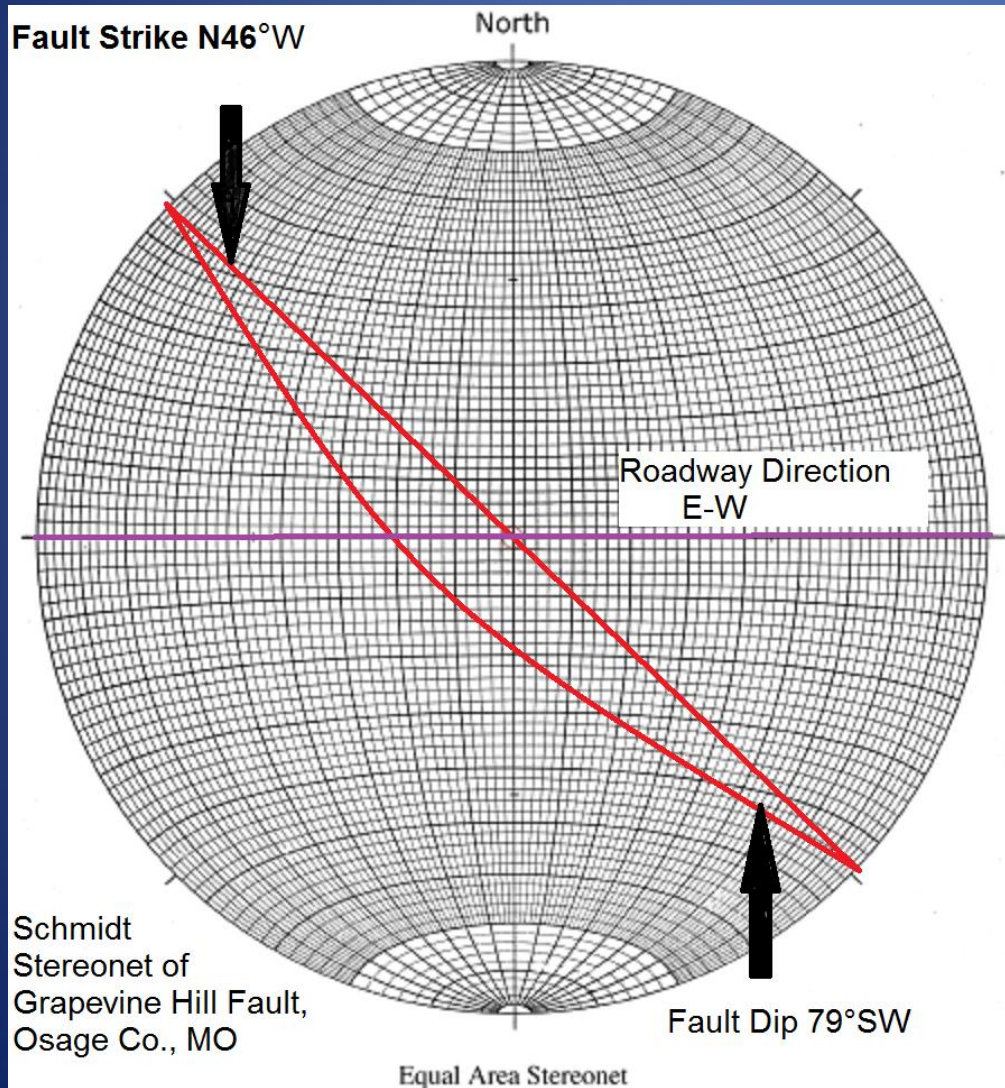
# Analysis indicates no problem.

- The dip of the fault doesn't 'daylight' to the north where the cut is, so we anticipate few problems, if any.
